General Information

Property Address **** South ***** Lane
City ***** **State** Oregon **Zip** *****

Others Present Client and broker **Property Occupied** No
Estimated Age 15 years **Entrance Faces** North (approximately)
Inspection Date 12/23/2010
Start Time 1:30 PM **End Time** 4:15 PM
Temperature 36°
Weather Overcast **Soil Conditions** Damp
Electric On Yes
Gas/Oil On Not Applicable
Water On Yes
Space Below Grade Crawlspace
Building Type Manufactured home **Garage** None (outbuildings not inspected)
Additions/Modifications YES--client is responsible to verify permits
Permits Obtained Contact your local building department **How Verified** Client is responsible to verify permits

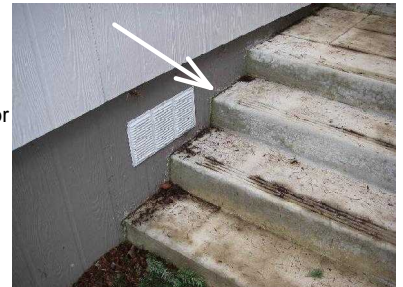
==No handrail present at a stairway that is more than 3 risers in height
==Concrete was poured over the siding/ trim/ and perimeter skirting -- this is a potential water entrapment area between the structure and concrete -- recommend regular maintenance and inspection of this area to be sure that surface water or wind driven rain on the porch does not drain or run between the concrete and the house -- this could potentially lead to water damage/ hidden undetectable damage/ and hidden infestation of wood destroying organisms [see picture]

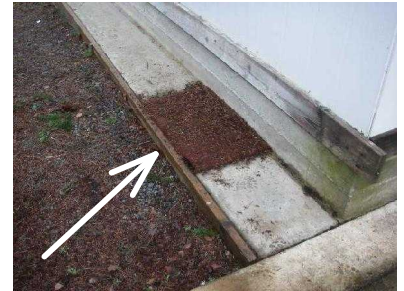
- MAINTENANCE** **Wood Destroying Organism Conductive Conditions:** Yes
 ==Unremoved concrete forms observed (as seen at the SE corner of of the patio area) [see picture]
 ==Vegetation touching and covering the siding
 ==Gutters overflowing and causing moisture accumulation on the ground next to the structure

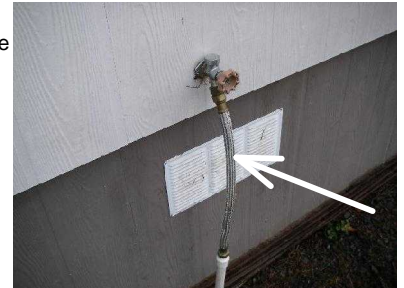
- Not Inspected** **Retaining Walls:** Concrete
 ==Note: Retaining walls fewer than 3' tall/ landscaping wall/ terracing/ walls that do not appear to directly affect the grading directly adjacent to the structure are not inspected/ evaluated/ or reported and are considered outside the scope of this inspection -- any concerns regarding these areas are mentioned only as a courtesy
- Not Inspected** **Lawn Sprinklers:** Underground--not inspected
 ==The sprinklers do not appear to be a permanent installation -- they appear to require turning on the hose bib for the system(s) to function (as seen at the north end) [see picture]

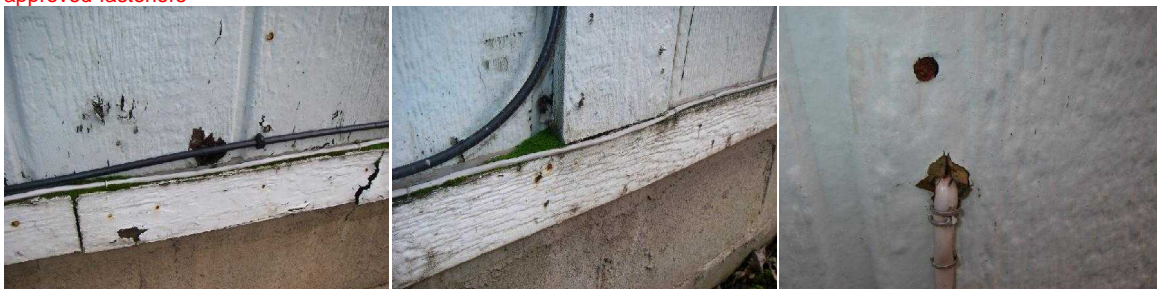
- REPAIR-REPLACE** **Type:** Composite wood- panels (resembles LP®)
 ==The siding is soft/ damaged/ deteriorated at some areas (as seen at but not limited to: the bottom edges at the south exposure/ bottom edges at the gable end of the front porch) -- composite siding material like this has a history of failing and deteriorating when penetrated by moisture -- some areas appear to need replaced or repaired to help prevent further damage and deterioration -- consult a qualified licensed contractor for further questions/ information and/or a further evaluation to determine the extent of damage at these areas and the need for appropriate repairs or modifications -- be sure to keep the bottom edges of the siding completely sealed/ painted and any holes through the surface from over driven nails/ removed fasteners/ or utility penetrations properly caulked and sealed -- most siding this age and type has been replaced due to serious failure

==A few utility opening(s)/ penetration(s) and/or hole(s) from removed nails observed that appear to need properly caulked or sealed with an appropriate material (typically a polyurethane based sealant such as Vulkem® or Quad® is preferred by today's industry standards)
 ==Rusty or non-galvanized nails appear to have been improperly used at some locations -- recommend removal and replacement with approved fasteners

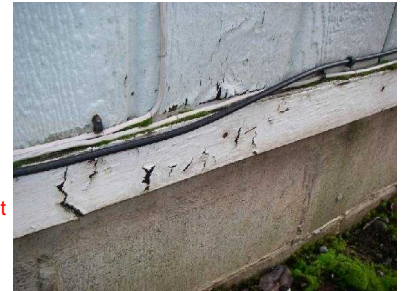
==The trimwork is soft/ damaged/ deteriorated at some areas (as seen at but not limited to: the bottom edges at the south exposure) -- composite trimwork material like this has a history of failing and deteriorating when penetrated by moisture -- some areas appear to need replaced to help prevent further damage and deterioration -- consult a qualified licensed contractor for further questions/ information and/or a further evaluation to determine the extent of damage at these areas and the need for appropriate repairs or modifications -- most trimwork this age and type has been replaced due to serious failure
 ==Horizontal and flat trim areas need regular maintenance and inspection to keep the caulking/ paint sealed and intact -- this is needed to help water from soaking into the trim boards and help prevent moisture from running behind or becoming trapped between the trim and siding or other materials

==Rusty or non-galvanized nails appear to have been improperly used at some locations -- recommend removal and replacement with approved fasteners
 ==Paint finish failure and/or deterioration at some areas
 ==Not fully visible due to the height from the ground

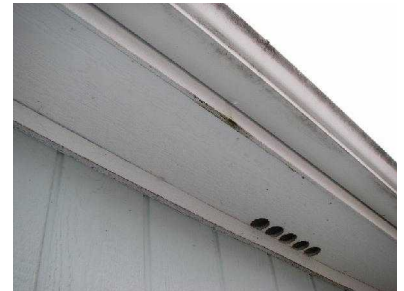
==Some small places observed where the gutters are leaking behind the drip edge flashing or down the fascia these areas may eventually be prone to water damage

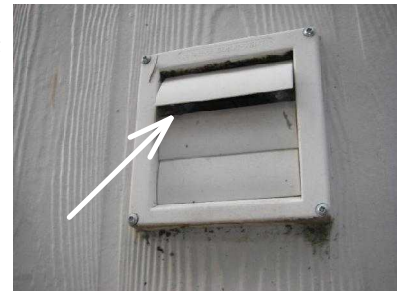
==Baffle(s) appear to be stuck open with dryer lint -- dryer vents like this type have a tendency to get clogged and restricted with dryer lint -- recommend regular inspection and cleaning as needed [see picture]

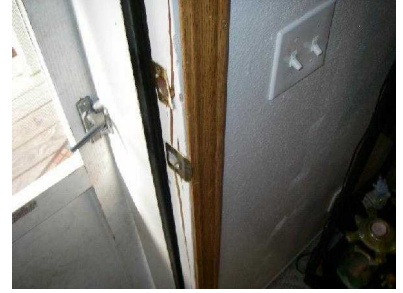
==Physical damage/ the door jamb is cracked and split -- appears to have been kicked-open in the past which has broken the jamb -- consult a qualified licensed door specialty contractor for further questions/ information and/or to determine the need for appropriate repairs or replacement
 ==Note: Screen door(s) are not inspected/ evaluated/ or reported on and are considered outside the scope of this inspection

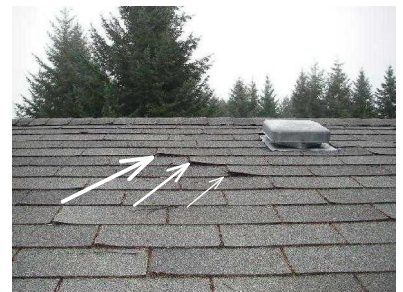
==Some shingles observed that appear to be lifted up or slightly loose at the tab edges -- this can sometimes cause the shingles to be prone to blowing off in high wind conditions easier [see picture]
 ==Regular maintenance and inspection is advised -- consult a qualified licensed roofing contractor for a further evaluation to determine life expectancy information which is outside the scope of this inspection

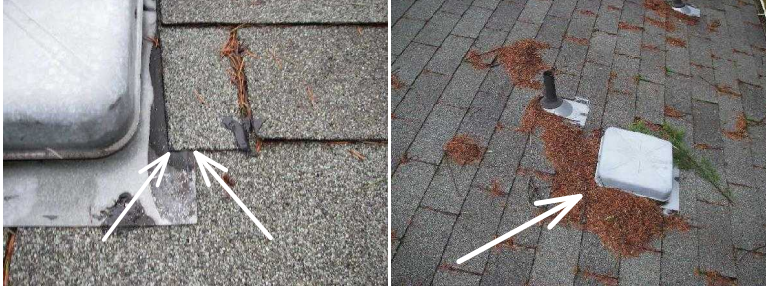
==The roofing material does not appear to overlap the roof vent cap flashing very far at most of the vents -- these areas appear that they may be prone to allowing wind driven rain or moisture penetration (especially if snow or debris builds up around the flashing and causes water to backup) -- consult a qualified licensed roofing contractor for a further evaluation/ questions and/or to determine the need for appropriate modifications or repairs [see picture: left]

==Not fully visible due to built-up organic matter around the vent [see picture: right]

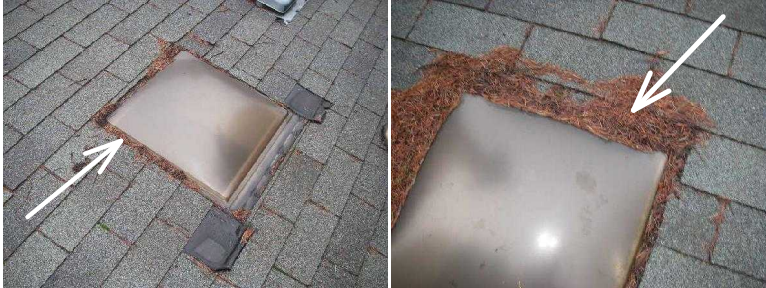
==Skylights like this have a tendency to be troublesome and prone to problems with leaking -- signs of past leaking was observed on the ceilings of the bathrooms around the skylights (as seen at the interior of the house) -- recommend regular inspection and maintenance of this area to be sure that the leaking has been properly repaired -- consult a qualified licensed roofing contractor for further questions/ information and/or a further evaluation [see picture: left]

==Not fully visible due to built-up organic matter around the skylight [see picture: right]

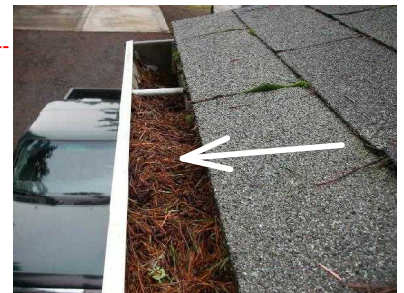
==The gutters are impacted with debris and the drains are blocked -- appears to need cleaned now -- regular cleaning/ maintenance/ inspection is advised to keep drains clear -- this will help prevent overflowing of the gutters which can contribute to water damaged siding or moisture penetration into the crawlspace area [see picture]

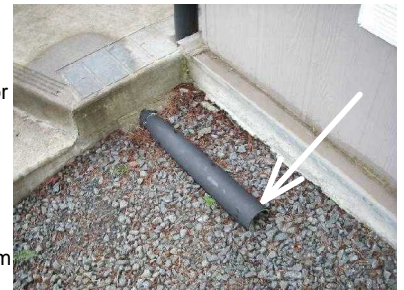
==Apparent unused drain observed at the driveway -- the pipe is filled with gravel which could possibly cause the drain to become clogged (not tested to verify if the drain is functional) -- recommend properly capping off the pipe to help prevent the rest of the downspout drain system from potentially become plugged [see picture]

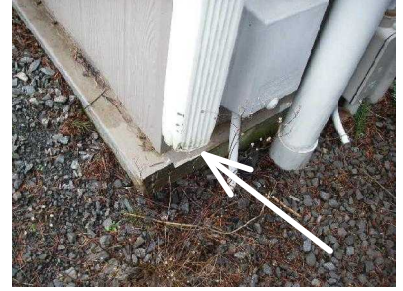
==Downspout is terminating against the perimeter skirting (as seen at the SW corner) -- appropriate downspout extensions or underground drainage pipes are recommended to route the water away from the structure [see picture]

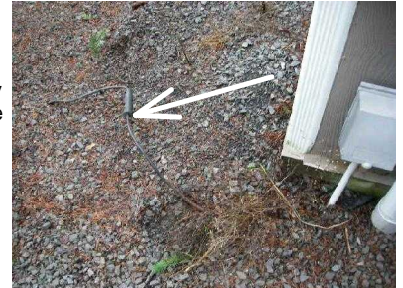
==An unknown wire was observed sticking out of the ground (as seen at the SW corner of the structure) -- unable to determine the function and/or reason for this (appears to be installed in a sub-standard method) -- appears to be a telephone wire but unable to verify -- consult the local utility company for further questions/ information and/or a further evaluation (note: low voltage systems are considered outside the scope of this inspection and any mention of items related to these systems is done as a courtesy) [see picture]

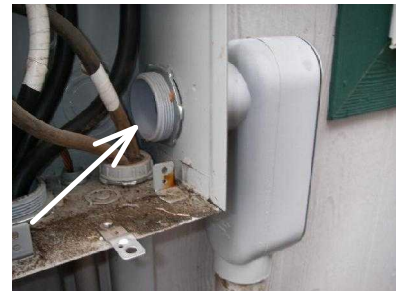
==Additions to the system were observed without a permit seen at the panel -- recommend consulting the local building department that oversees electrical work in this area and/or a qualified licensed electrical contractor for further information/ questions/ or an evaluation

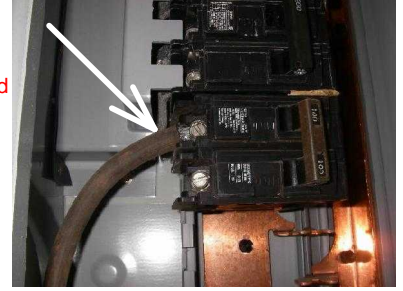
==240V double pole breaker appears to be improperly in use for a single 120V circuit -- this appears to be a sub-standard or amateur installation method (recommend that the other end of this circuit be identified and further evaluated for other possible wiring or electrical safety issues) consult a qualified licensed electrician for further questions or an evaluation [see picture]

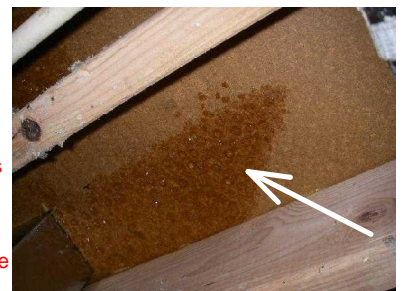
==Water condensation observed on the underside of the sub-floor where exposed at some small areas (as seen in the crawlspace under the hallway bathroom) -- unable to determine or verify the reason or cause of this issue -- this appears to indicate excessive humidity or elevated moisture levels at this area -- consult a qualified licensed contractor who specializes in moisture problems/ investigations and/ remediation and is familiar with this type of structure for further questions/ information and/or a further evaluation to determine the need for appropriate modifications or repairs [see picture]

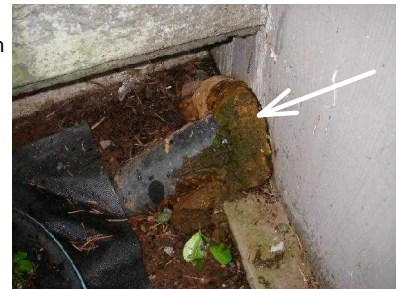
==The sewer pipe penetration through the skirting has been repaired by sealing around the pipe with expanding foam -- expanding foam can be easily chewed through by rodents or vermin or used for nesting material and is typically not considered a permanent sealing solution [see picture]

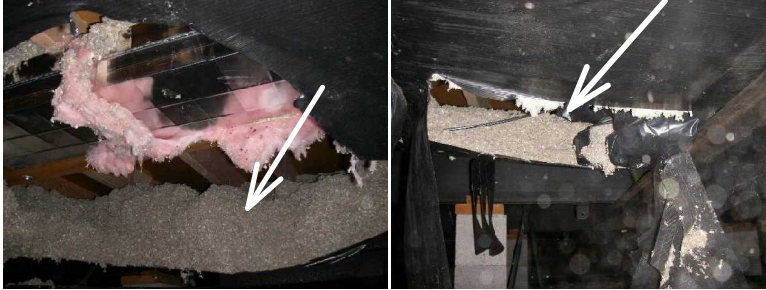
==Missing at a few areas (especially at under the hallway bathroom/ SW bedroom) where the factory floor covering have been cut open or removed [see pictures]

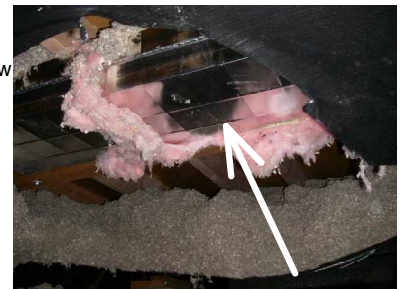
==Insulation is missing on the exterior of the sheetmetal ductwork as seen in the crawlspace at several large areas (where the factory floor covering is damaged and missing) -- this appears to allow constant energy loss when the furnace is in use [see picture]

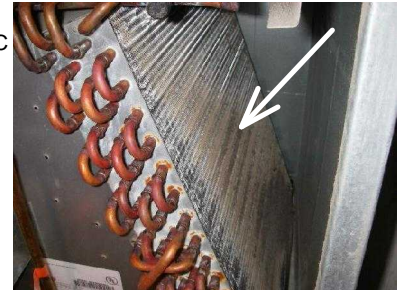
==Dust/ debris is blocking free air flow -- recommend a proper cleaning by a qualified licensed HVAC contractor to provide free air flow [see picture]

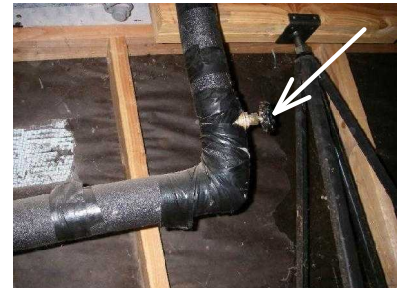
==A gate valve shutoff appears to be present (as seen in the crawlspace under the laundry room) -- recommend a further evaluation to verify if this is the main shutoff or a valve for another purpose (note: testing of valves like this is outside the scope of this inspection -- the valve was visually inspected only and not turned off or on) [see picture]

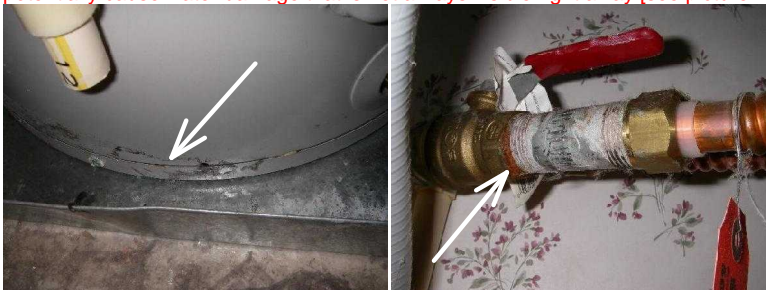
==Rust or corrosion observed on one of the galvanized supply line fittings over the water heater -- regular inspection of the water heater is advised (especially at the top) and maintenance performed as needed -- the galvanized supply line fittings have a tendency to leak/ rust/ and potentially cause water damage that is not always visible right away [see picture: right]

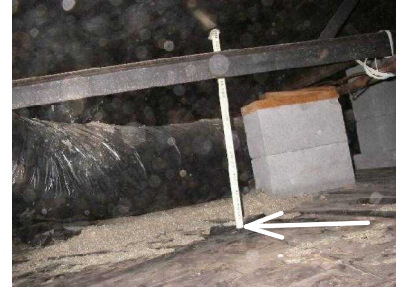
==Drain line on the pan is unfinished condition (as seen in the crawlspace) -- this appears to cause water to drain into the crawlspace instead of to the exterior of the structure -- recommend a further evaluation by a qualified licensed plumbing contractor for further questions/ information and/or to determine the need for appropriate modifications or repairs [see picture]

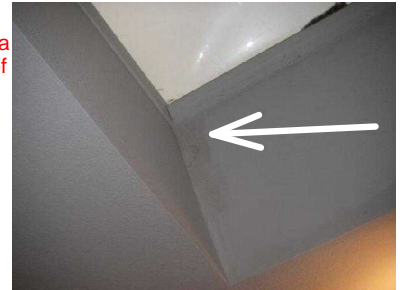
==Water stains and signs of apparent past roof leaking (as seen around the skylight) -- recommend a further evaluation by a qualified licensed roofing contractor to determine the exact cause or source of stains and to verify the need for appropriate modifications or repairs [see picture]

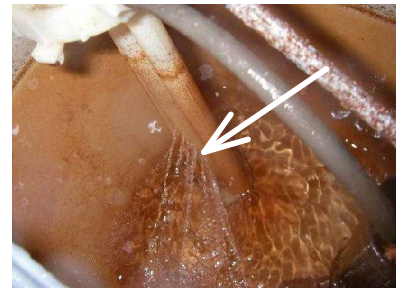
==The tank filling valve appears to be damaged/ defective and was observed continuously running (unable to determine or verify the reason or cause of this issue) -- consult a qualified licensed plumbing contractor for further questions/ information and/or a further evaluation to determine the need for appropriate modifications or repairs [see picture]

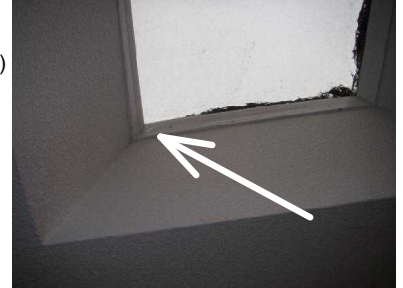
==Some small water stains and signs of apparent past roof leaking (as seen around the skylight) (see notes above under "Hallway Bathroom- Ceiling" for further information that may apply here also) [see picture]

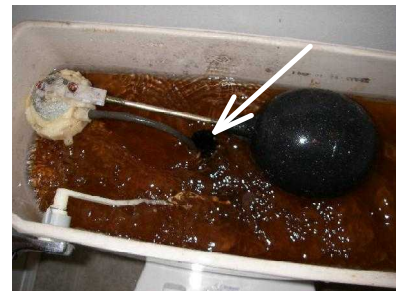
==The tank filling valve appears to be damaged/ defective and was observed continuously running (unable to determine or verify the reason or cause of this issue) -- consult a qualified licensed plumbing contractor for further questions/ information and/or a further evaluation to determine the need for appropriate modifications or repairs [see picture]

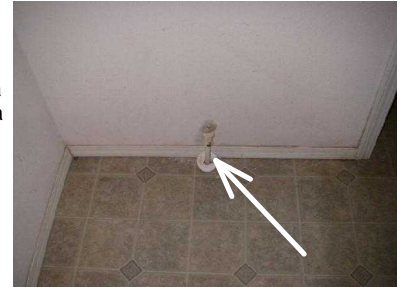
==Valve appears to be loose/ poorly fitting and/or has excessive movement -- pipe and/or valve appears it could be prone to physical damage or breaking if the refrigerator is pushed tightly against the wall -- consult a qualified licensed plumbing contractor for further questions/ information and/or a further evaluation to determine the need for appropriate modifications/ repairs/ or replacement with a recessed wall valve [see picture]

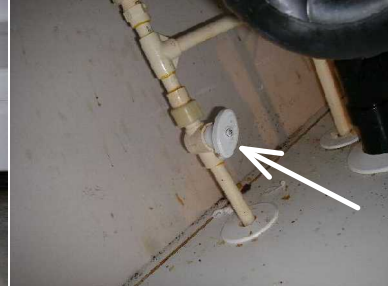
==No independent shutoff valve observed under the sink -- the water supply lines appear to be poorly supported and could be prone to physical damage under the sink -- consider appropriate added support or modifications for protection [see picture: right]

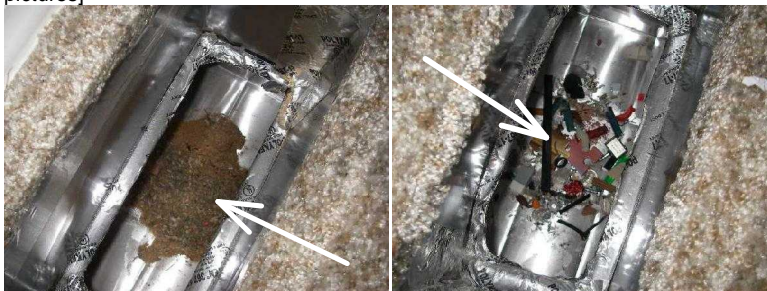
==Ductwork has some debris inside as observed at a few of the floor register areas -- recommend vacuuming/ cleaning out as needed [see pictures]
