Roof (Continued)

Crawl Space

REPAIR-REPLACE Summary

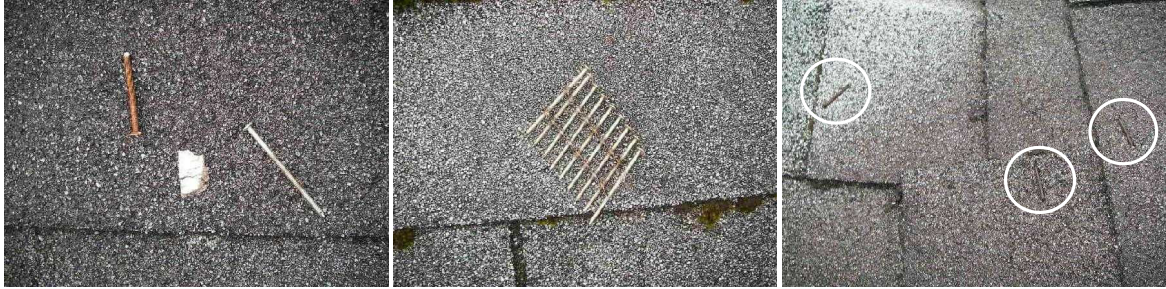
Unable to Inspect: 10%:

==Not fully walked due to the roof being too steep or treacherous at some areas -- consult a qualified licensed roofing contractor for a further evaluation or questions

==Not fully visible due to moss growth and/or organic matter

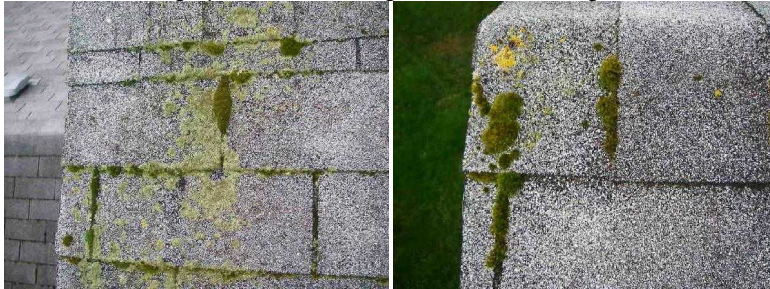
Moss Growth: Yes:

==Some moss growth observed -- recommend a treatment and/or removal in an approved method now and on a regular basis -- avoid high pressure washing as this can damage the roof and reduce life expectancy of materials

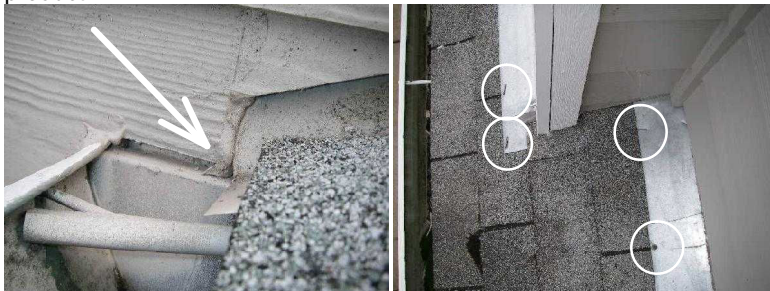
Flashing: Metal:

==Gutter end cap areas that are against the siding appear troublesome and would benefit from appropriate added "kick-out" flashing -- these areas appear to be depending on caulking to help prevent water entry behind the siding or into the walls -- consult a qualified licensed roofing contractor for a further evaluation and/or modifications -- strongly recommend regular maintenance and inspection of these areas

==Exposed fasteners on flashings and ridges would benefit from being sealed with an approved polyurethane caulking product

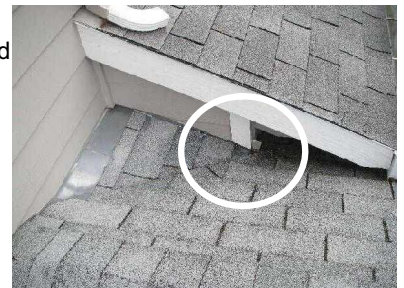
Valleys: Metal:

==Valley area at over the dining/ nook area appears to need regular maintenance and inspection to help prevent debris build up which could possibly lead to water backing up over the flashing and causing leaking

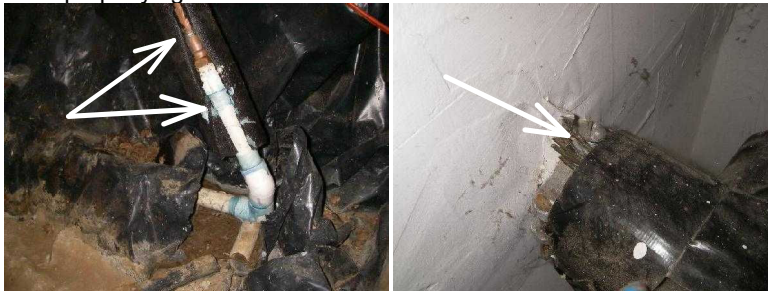
REPAIR-REPLACE **Ground:** Plumbing bond--but not fully visible:
==Plumbing water main transitions to plastic non-metallic pipe as seen in the crawlspace -- this appears to affect or void the plumbing bond to earth connection -- consult a qualified licensed electrical contractor for a further evaluation or to determine the need for appropriate repairs/ replacement/ or modifications
==Grounding clamp is slightly loose at the plumbing bond -- this can affect the safety of the electrical system -- appears to need properly tightened

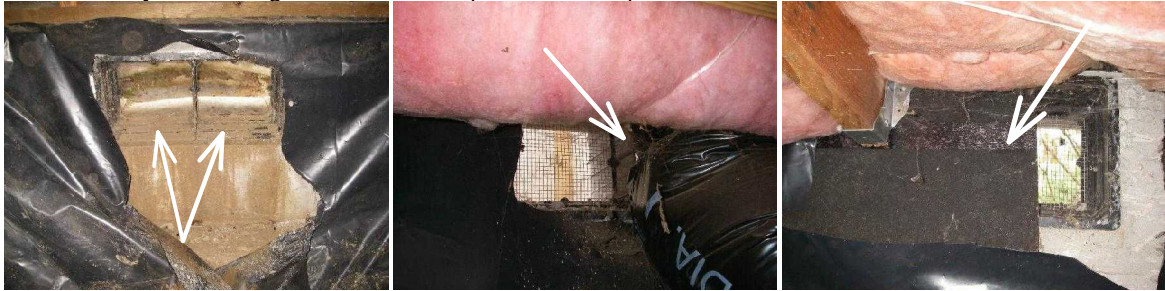
REPAIR-REPLACE Ventilation: Foundation vents:

- ==Several damaged/ loose and/or missing screens -- check every vent and repair as needed to keep ventilation open and provide maximum 1/8" openings -- use 1/8" galvanized wire cloth where needed -- this helps prevent animal/ rodent/ and/or insect entry
- ==Heat ducts/ floor insulation/ and vapor barriers are blocking the airflow at some vents -- recommend securing the ducts out of the way or trimming the insulation/ vapor barriers to provide total vent airflow

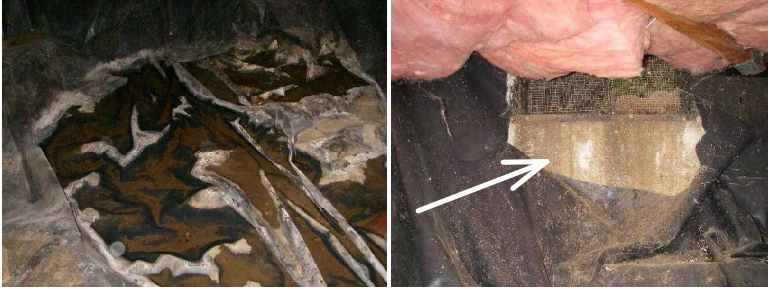
REPAIR-REPLACE Moisture Penetration: Yes **Moisture Location:** Several areas:

- ==Some puddles observed today as seen under the living room and entryway at the along the north foundation walls -- up to 1/2" - 4" of standing water appears to have been present at these areas in the past judging by the water stains on the vapor barrier -- consult a qualified licensed contractor who specializes in crawlspace moisture penetration problems and drainage issues for a further evaluation and to determine the need for appropriate repairs or modifications

- ==Water stains observed at some of the foundation vents indicating surface water spilling into the crawlspace -- strongly recommend proper vent wells and grading corrections at the exterior to help prevent this

- ==Signs of previous water penetration observed at several isolated areas throughout the crawlspace in the past as evidenced by water staining or silt on the black plastic moisture barrier/ water stains on the foundation footing/ stemwall

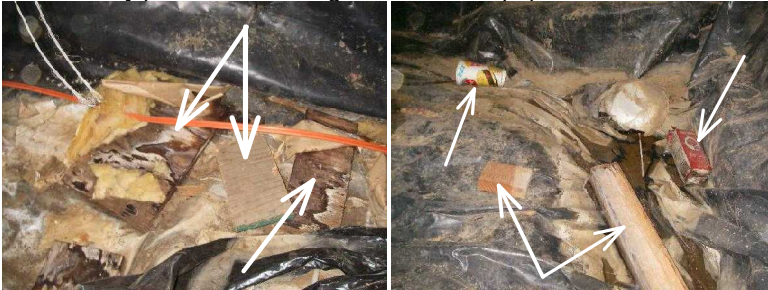
Wood/Cellulose Debris: Yes:

==Wood/ cellulose debris observed in the crawlspace -- recommend removal of all pieces that are large enough to be raked up with a common garden rake as these are considered conducive to wood destroying organism infestation -- this includes any product containing wood such as paper/ cardboard/ and the like

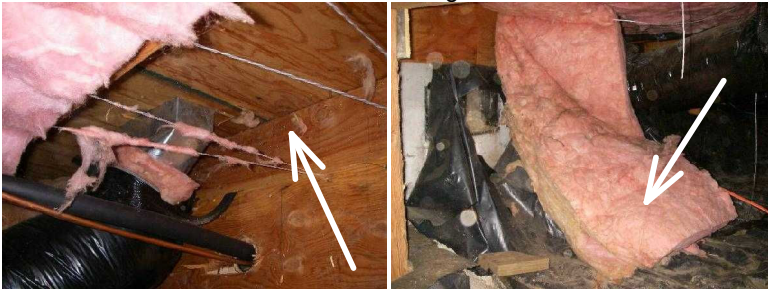
Insulation: Fiberglass in the floor framing:

==Insulation is fallen/ loose and/or missing at a few areas

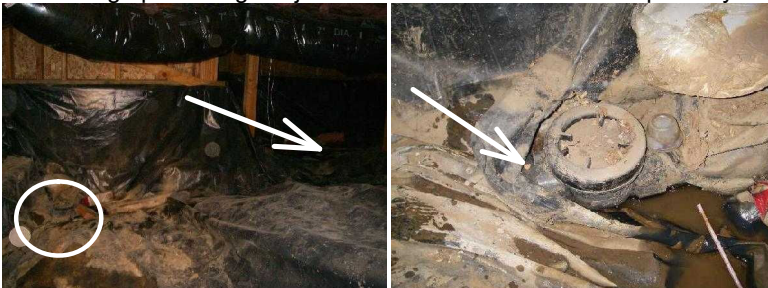
Low-Point Drain: ABS--but not fully visible:

==Low point drain does not appear to be located where standing water if present in the crawlspace will be able to flow into the drain by gravity -- water appears it will have to puddle or buildup at areas (especially under the living room bay window/ along the north garage foundation) before it will all enter into the drain -- crawlspace grading corrections or additional modifications may be needed to eliminate future moisture conditions and to help the low point drain perform as intended -- consult a qualified licensed contractor for a further evaluation or questions

==Drain appears to be blocked off by the black plastic moisture barrier around the drain opening

==Drain appears it could be subject to becoming blocked with the debris present in the crawlspace -- recommend removal or cleaning up of foreign objects around the drain that could possibly block the drain from properly functioning
