General Information

Property Address **** South ***** Lane
City ***** **State** Oregon **Zip** *****

Others Present Client and broker **Property Occupied** No
Estimated Age 15 years **Entrance Faces** North (approximately)
Inspection Date 12/23/2010
Start Time 1:30 PM **End Time** 4:15 PM
Temperature 36°
Weather Overcast **Soil Conditions** Damp
Electric On Yes
Gas/Oil On Not Applicable
Water On Yes
Space Below Grade Crawlspace
Building Type Manufactured home **Garage** None (outbuildings not inspected)
Additions/Modifications YES--client is responsible to verify permits
Permits Obtained Contact your local building department **How Verified** Client is responsible to verify permits

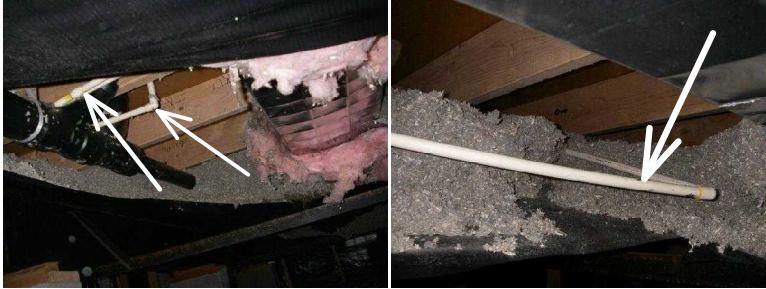
==This type of product has a history of becoming fragile or brittle with age -- care should be exercised around any of the exposed plumbing pipes to be sure that these pipes are not physically damaged

==Most of the system is not visible or inspected due to finished surfaces -- this limits our evaluation and inspection

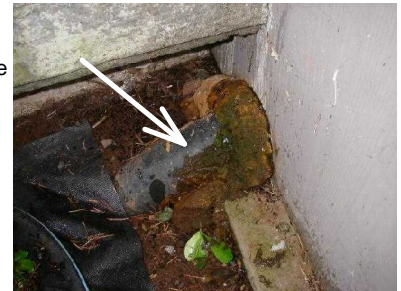
==Most of the system is not visible or inspected due to finished surfaces

==Note: Septic systems are outside the scope of this inspection and the systems/ components associated with them are not evaluated -- consult a qualified licensed contractor who specializes in this area for a further evaluation/ questions/ or information

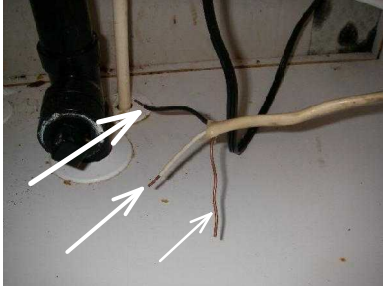
==Dishwashers can have a tendency to leak after not being used and/or being in a vacant house for long periods of time -- caution should be exercised when first used -- consult a qualified licensed plumbing contractor for a further evaluation/ questions/ or inspection

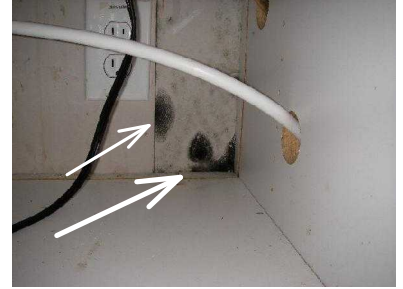
==Mold and/or mildew growth is outside the scope of this inspection -- black spotting or suspected growth observed (as seen on the wall under the sink) -- CONSULT an Industrial Hygieneist and/or qualified testing laboratory for more information or an evaluation of these and all environmental concerns [see picture]
